CO₂OL BRICKS

Upgrading the energy performance at Kavalergården

Project number: 201416
Version 1
Version: 1
Document no.: 125593739
Authors: HMT, JBI
Supervision: ARJ
Approval: ARJ

Henrik Monefeldt Tommerup, NIRAS A/S
Jacob Birck Laustsen, NIRAS A/S

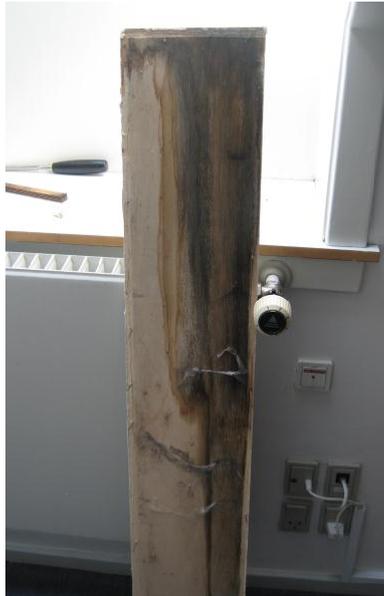
Furthermore, the roof and other parts of Kavalergården were in bad shape and needed refurbishment in general. Investigations had shown extensive wood decaying fungus attacks as a result of leakages in the roof and the joint between VELUX windows and roof. Furthermore, leaky or missing/wrongly placed vapour barrier had resulted in several mould attacks in the roof constructions. This general refurbishment was carried out as a part of the energy upgrade of the buildings.

Photo 7. Wooden beam from the old roof construction attacked by mould.

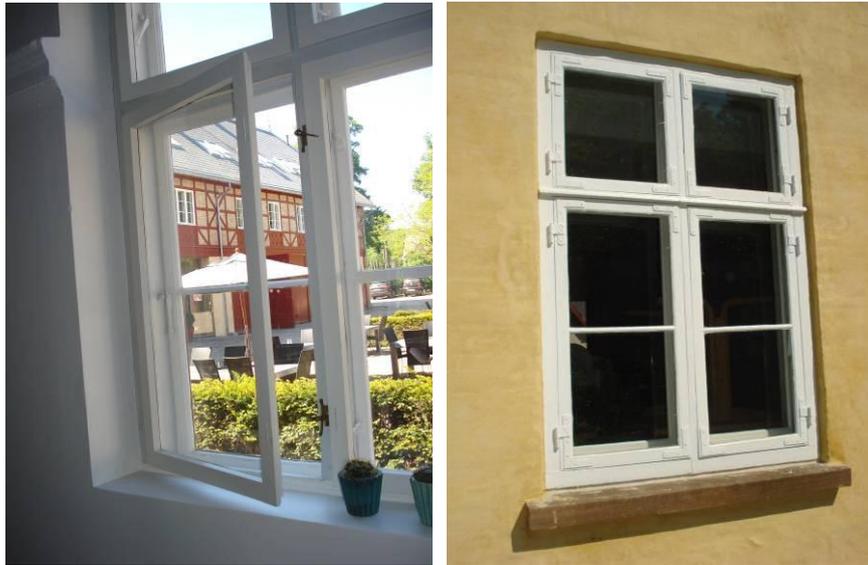
Photo 8. Storm windows with new energy-efficient glass and sealing strips (left). Typical wooden "Dannebrog" window with characteristic hinges and angle iron (right)

Re 2: Storm window glass was replaced with energy-efficient glass and new sealing strips were installed. The window U-value was reduced from roughly 2.8 to 1.8 W/m²K (see Photo 8).

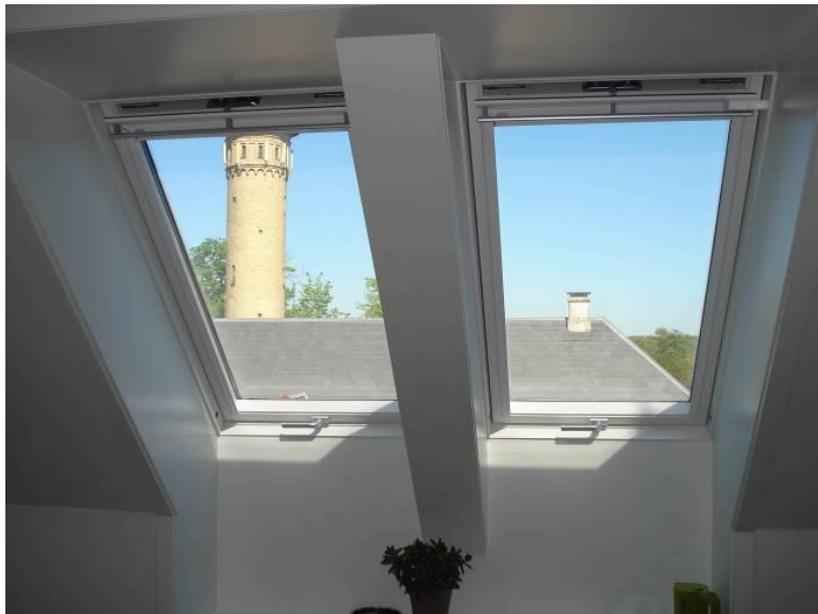
Photo 9. VELUX roof windows placed 2 by 2 to the north.

Existing old VELUX roof windows with double glazing were replaced by new similar windows VELUX GPL M08 with energy-efficient double glazing (18 units). U-value was reduced roughly from 3.0 to 1.3 W/m²K.

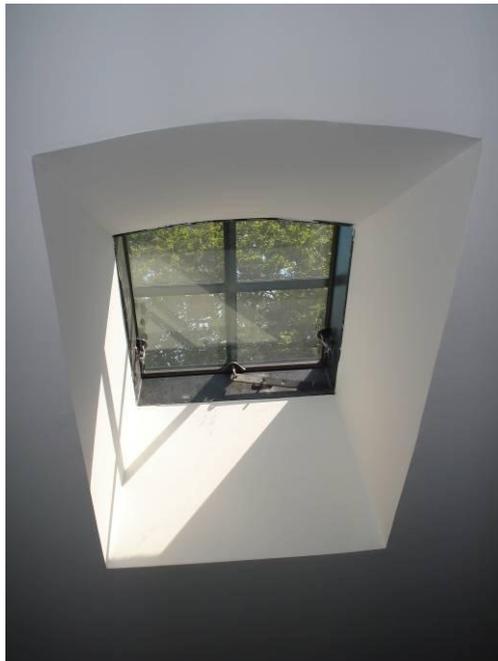
Photo 10. Cast iron roof window (GH Holbæk Jernstøberi) after the refurbishment

New roof windows to the south facing part of the roof are cast iron windows (4 units) with coupled and insulated window frame. U-value is reduced roughly from 5.8 to 1.9 W/m²K. (<http://www.ghjern.dk/>).

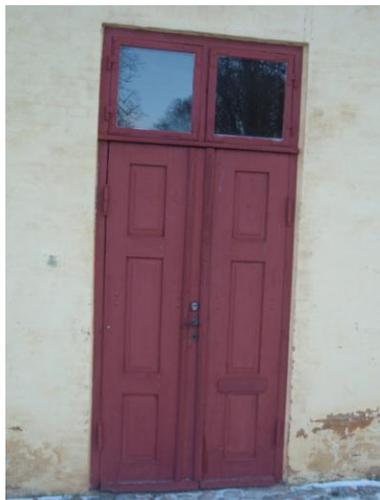
Photo 11. Two doors were repaired and storm windows installed above.

Two old doors were repaired and storm windows with energy-efficient glass were mounted above the doors.

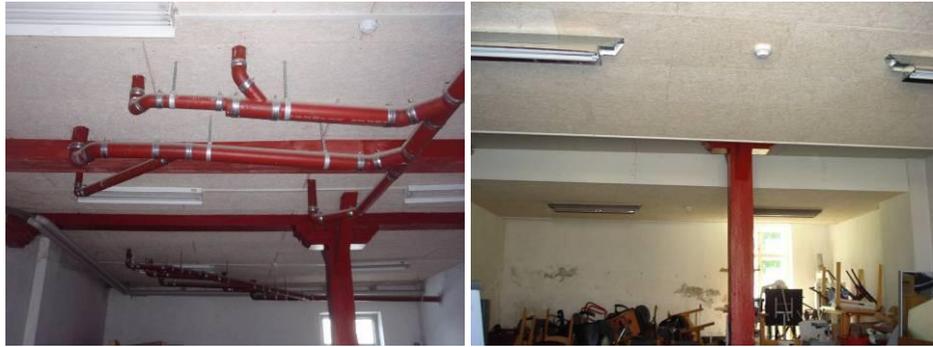
Photo 12. Ceiling in depot/garage before and after insulation. Pipes were moved to the area with wooden columns and beams.

The large depot/garage area at ground floor is unheated. The horizontal partition towards the first floor was insulated with 150 mm of mineral wool in a wooden frame structure and fitted with new similar ceiling sheets (Troldekt).

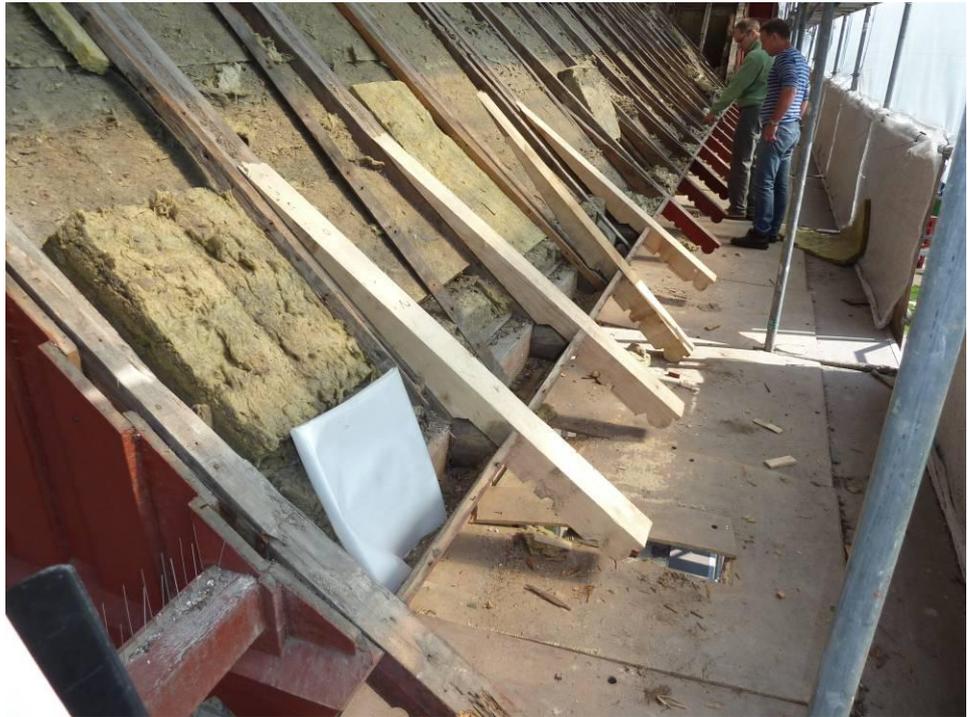
Photo 13. Eave without roof covering showing insulation and specially fitted eaves boards

The roof is provided with specially fitted eaves boards (see Photo 13).

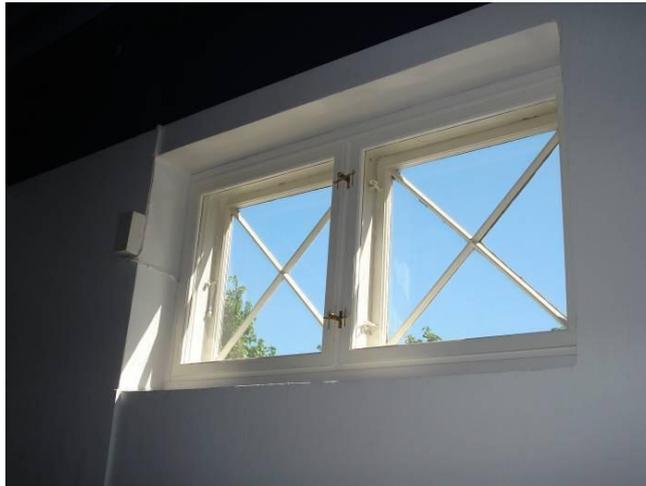
Photo 15. Small sized window with striking glazing bars. The thermal performance was improved by installing storm windows with energy-efficient glazing.

The same types of energy saving measures implemented to the Kavalers building were used in the Infirmary. An example is shown in Photo 15.

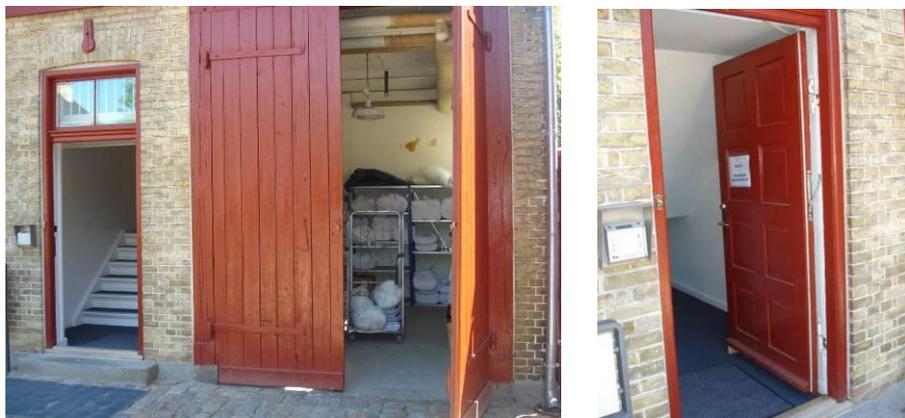
Photo 16. The door leaf was replaced and storm windows installed above the door.

All door leaves (5 units) were replaced with new ones incl. new energy-efficient storm windows above the doors. The door frame were mounted 5 cm from the facade surface and new joints around the doors were made using filling of tarred oakum and mortar finish.

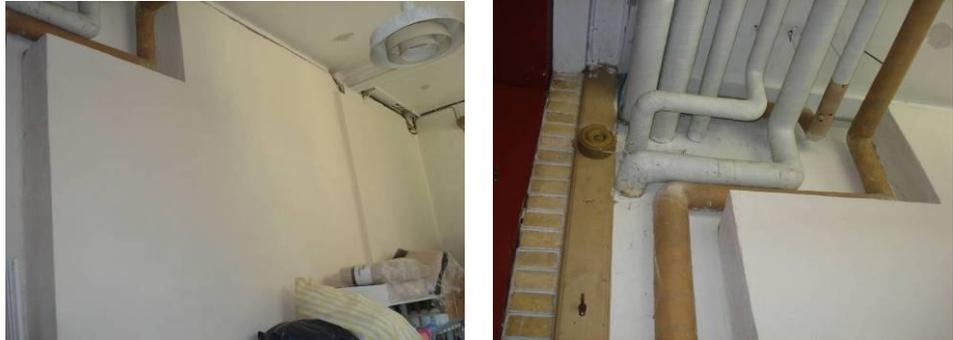
Photo 17. Wall insulation seen from the unheated depot.

The wall towards the unheated depot was fitted with 200 mm of mineral wool with plaster covering. Parts of the wall were not insulated due to piping (see Photo to 17). This extra heat loss is not of great importance because of other thermal bridges, e.g. horizontal partition.

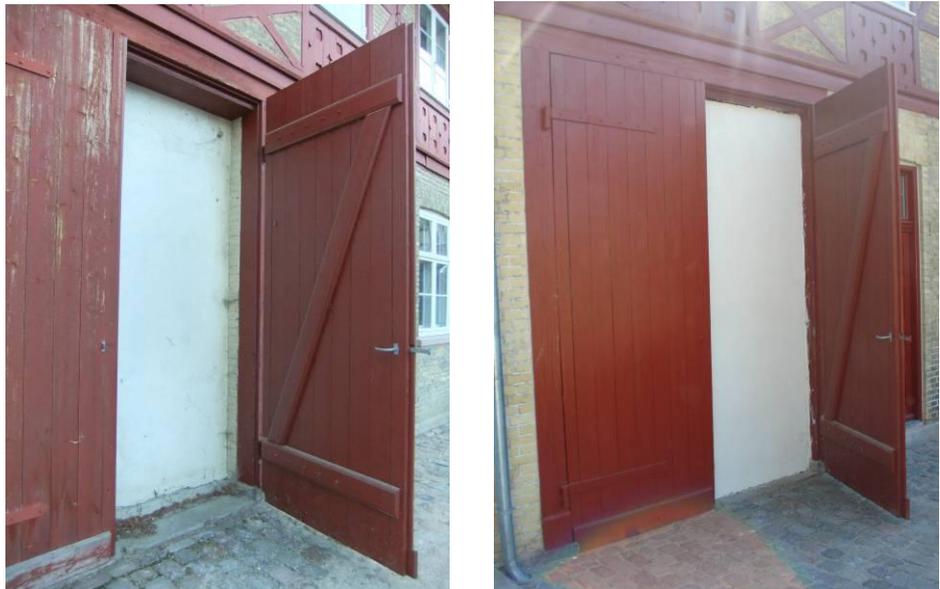
Photo 18. Covered door before and after repair and improved thermal insulation.

The door already covered was externally insulated with 200 mm of mineral wool with plaster covering (see Photo 18). The gate may not be altered due to the status as listed building.

Both measures reduced the U-value roughly from 2.5 to 0.2 W/m²K.

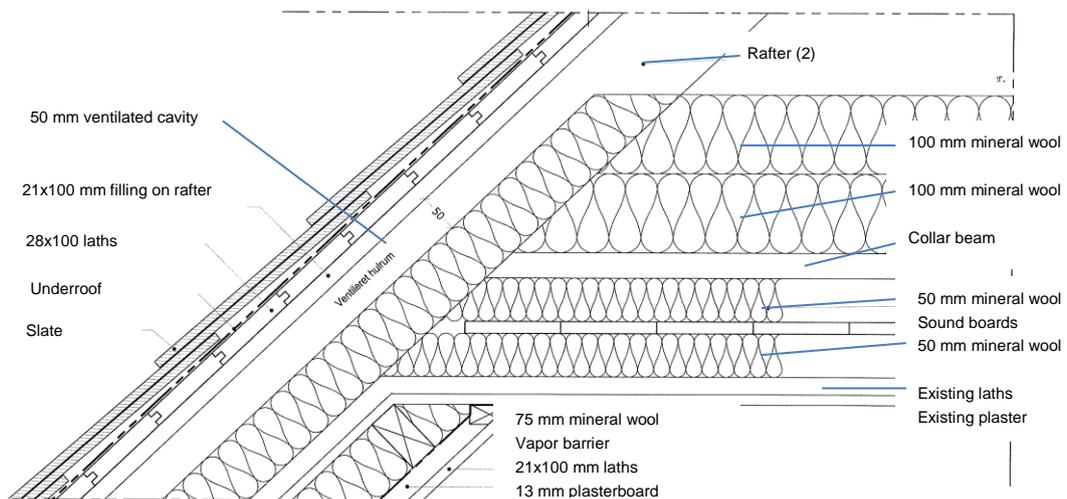
Figure 11. Attic floor – cross section in attic floor and sloping wall. 1 Slate, base felt, key and slot boards, laths on rafter. 2 Fungus attacked parts of rafters was replaced. 3 Attic floor with 200 mm mineral wool. 4 Collar beams were insulated both sides of sound boards.

Re 1: 200 mm of mineral wool was placed on the floorboards in two layers and with displaced joints between the insulation batts. The collar beam was insulated at the outermost 600 mm by blowing loose-fill mineral wool fibre insulation into the cavity between the timber beams - both below and above the sound boarding (no clay infill) – see Figure 11. Attic floor – cross section in attic floor and sloping wall. 1 Slate, base felt, key and slot boards, laths on rafter. 2 Fungus attacked parts of rafters was replaced. 3 Attic floor with 200 mm mineral wool. 4 Collar beams were insulated both sides of sound boards.

Figure 11 and Photo 19. U-value is reduced from 0.37 to 0.11 W/m²K.

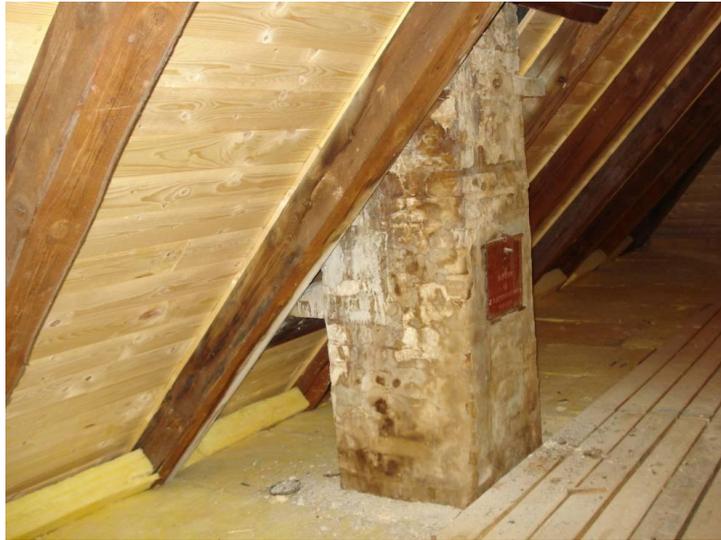
Photo 19. A view from the unheated loft showing insulation, rafters, under-roof, chimney and boardwalk.

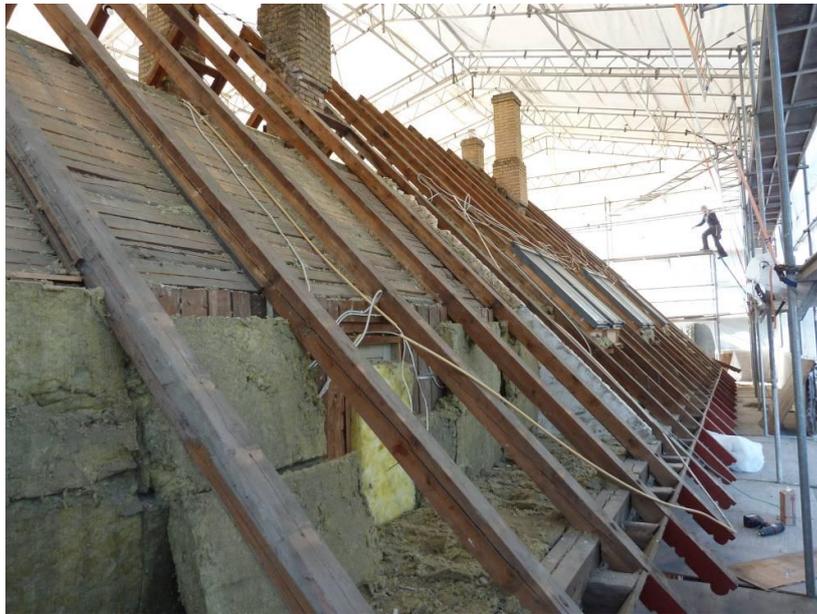
Photo 20. Roof before improved thermal insulation.

Re 2: The dimension of existing rafters (sloping beams) is 125 x 125 mm. 75 mm of mineral wool was installed from the outside including a 50 mm ventilation gap between insulation and the a solid underlay. The plaster of the existing wall construction (existing vapour barrier) was perforated before adding from the inside 75 mm mineral wool in a wooden frame construction, plastic foil vapour barrier, laths and gypsum board. U-value is reduced from 0.37 to 0.15 W/m²K.

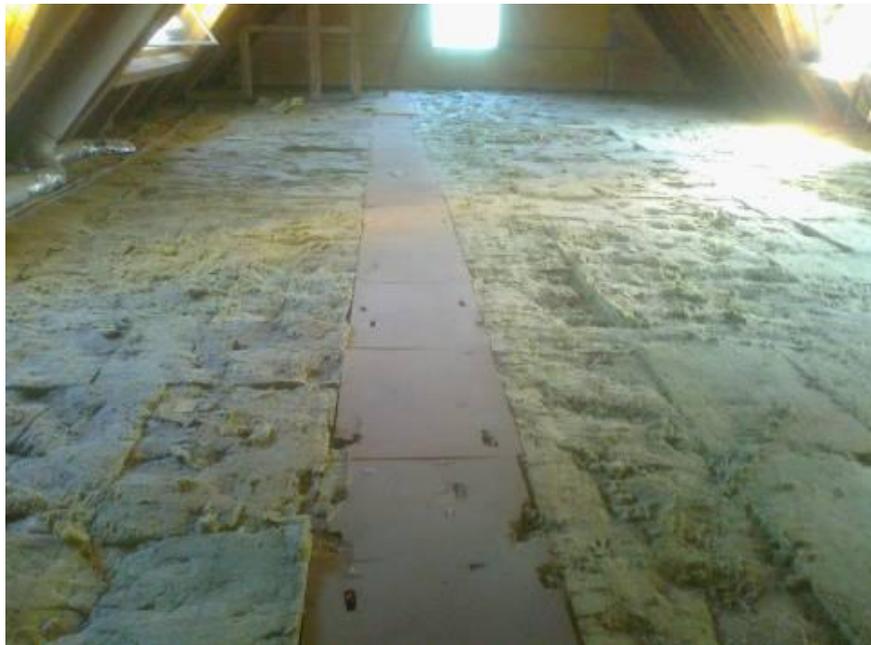
The existing attic is unheated. The horizontal insulation, partly trampled down, consists of a moderate 100 mm of mineral wool placed on the floor boards in one layer and therefore without displaced joints between the insulation batts. The risk of air gaps across the insulation layer increases the heat loss. The insulation was improved by blowing roughly 200 mm loose-fill mineral wool fibre insulation into the cavity between the timber beams. U-value was reduced from 0.37 to 0.11 W/m²K.

Photo 21. Unheated attic with existing insulation on top of the floor. Thermal insulation was improved by injecting the hollow floor with loose-fill insulation.
