CO₂OL BRICKS

Upgrading the energy performance at Kavalergården

Project number: 201416
Version 1
Version: 1
Document no.: 125593739
Authors: HMT, JBI
Supervision: ARJ
Approval: ARJ

Henrik Monefeldt Tommerup, NIRAS A/S
Jacob Birck Laustsen, NIRAS A/S

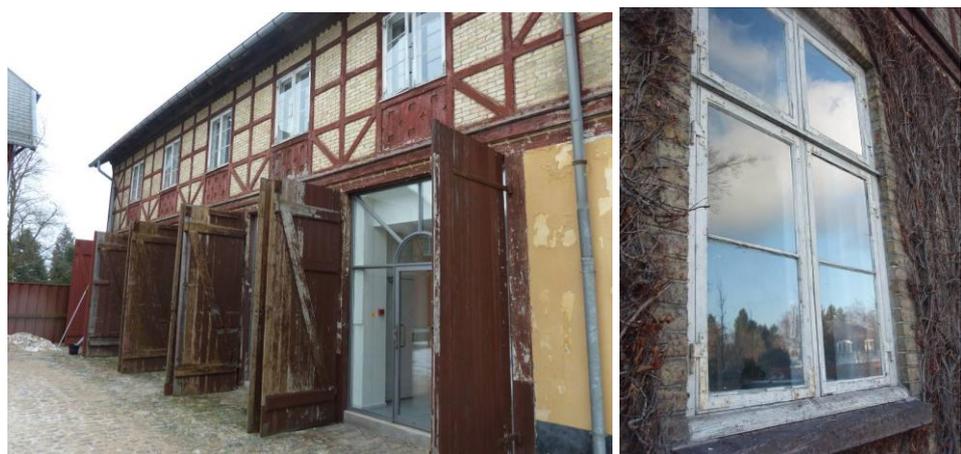
Figure 3 shows the facades of each of the 3 buildings. Facades to the left are facing the courtyard. A courtyard photo of the Kavalier building is shown in Photo 2 showing badly worn woodwork, e.g. gates, half-timbering and windows.

Photo 2. Facade of the Kavalier building before refurbishment.

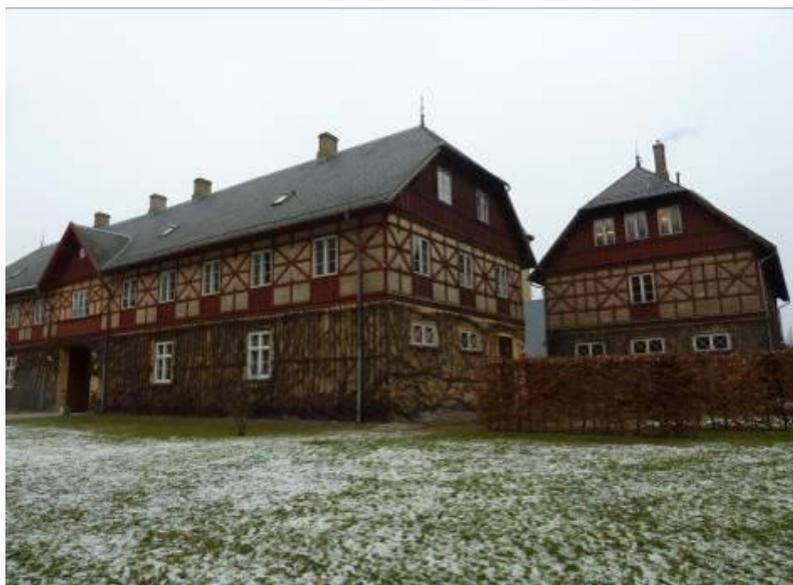
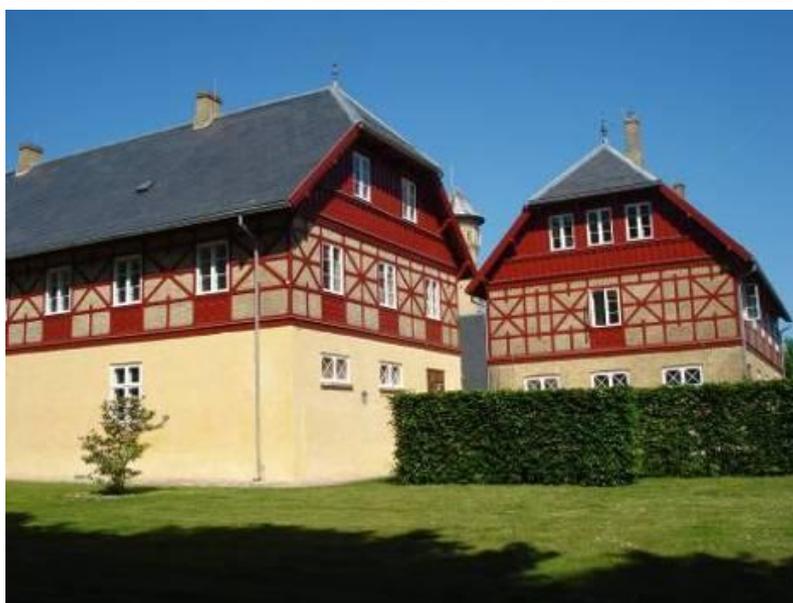
Photo 3. Kavalers building (left) and Infirmary building (right) – before and after refurbishment.

Photo 3 shows photos of the two main buildings before and after refurbishment. All woodwork was painted and ground floor espaliers were removed.

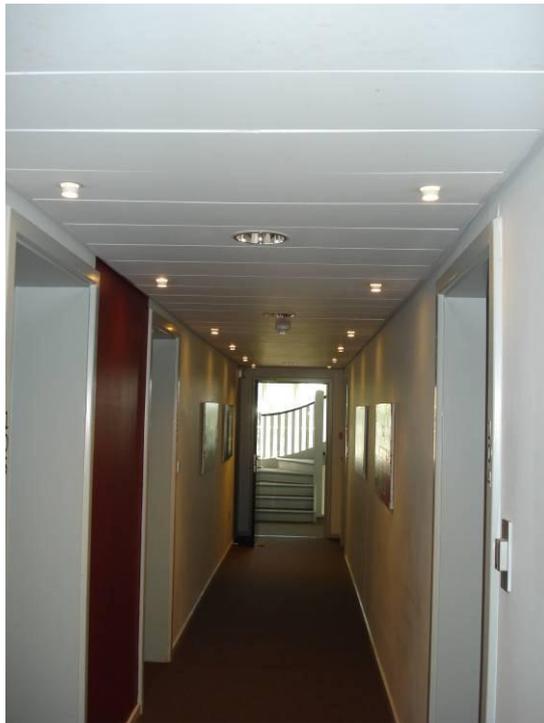
Photo 14. Hallway on first floor with energy efficient lighting (LED) installed.

Existing halogen light bulbs of the first floor hallway were replaced with energy-efficient LED lamps (32 units).

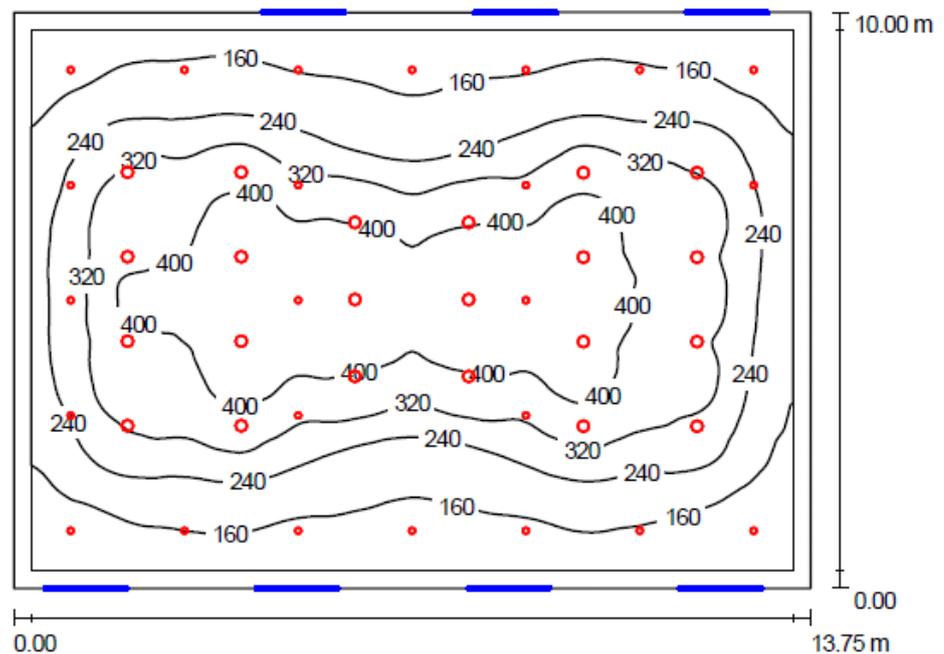
Figure 14. Calculated illuminance in Lux in the conference room on a horizontal surface at a height of 0.85 m.

The lighting in conference room was improved. The fixtures and halogen bulbs (46 units) were replaced with energy-efficient products. Detailed calculations of electricity savings were made:

Because of too high investment costs for implementing daylight regulation the new lighting system without daylight regulation was implemented. An electricity reduction of more than 50% is expected.

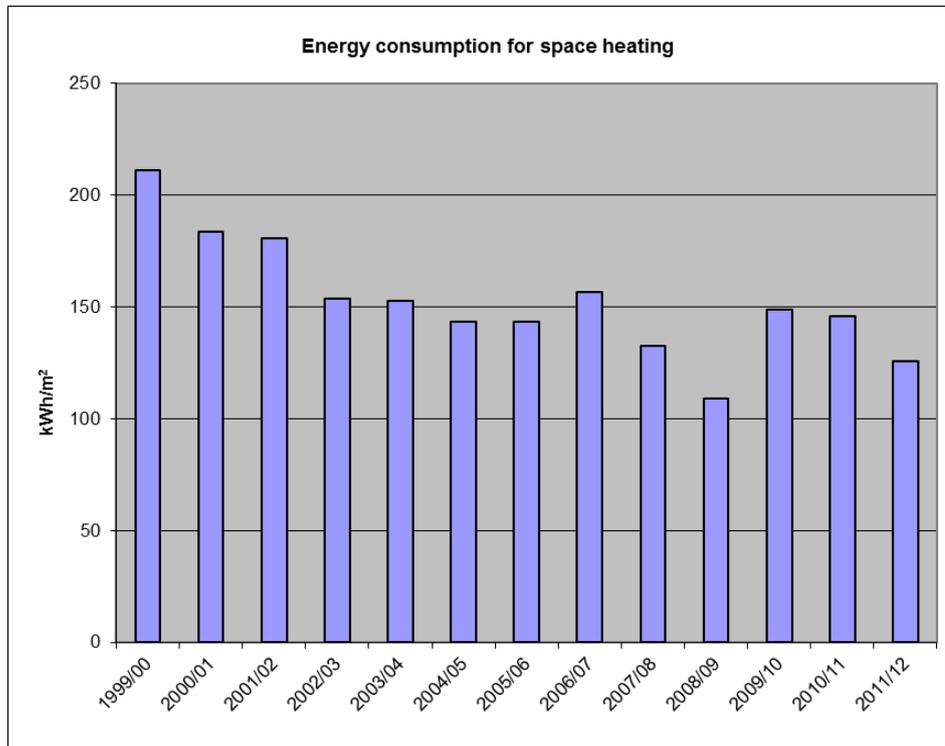
The expected space heat savings achieved by the energy upgrade and refurbishment were estimated to a total of 57 000 kWh/year equal to approximately 22 % of the space heat consumption. Measurements of the heat consumption before and approximately one year after the energy upgrade and refurbishment shows a decrease of 35 600 kWh/year equal to approximately 14 % or only 62 % of the expected heat savings.

The difference between the expected and the measured savings might be explained by the short period of measurements after the refurbishment is not representative for the future, a different use of the buildings or maybe higher indoor temperatures etc.

Figure 15. Energy consumption for space heating.
