# Co<sub>2</sub>ol-Bricks - Model Project Garden-City Elmschenhagen

June, 3rd 2013

In the **model project garden-city Elmschenhagen**, a combined consulting and funding program for energy efficient refurbishment of historic and monumental buildings in a residential area in Kiel is developed and implemented.

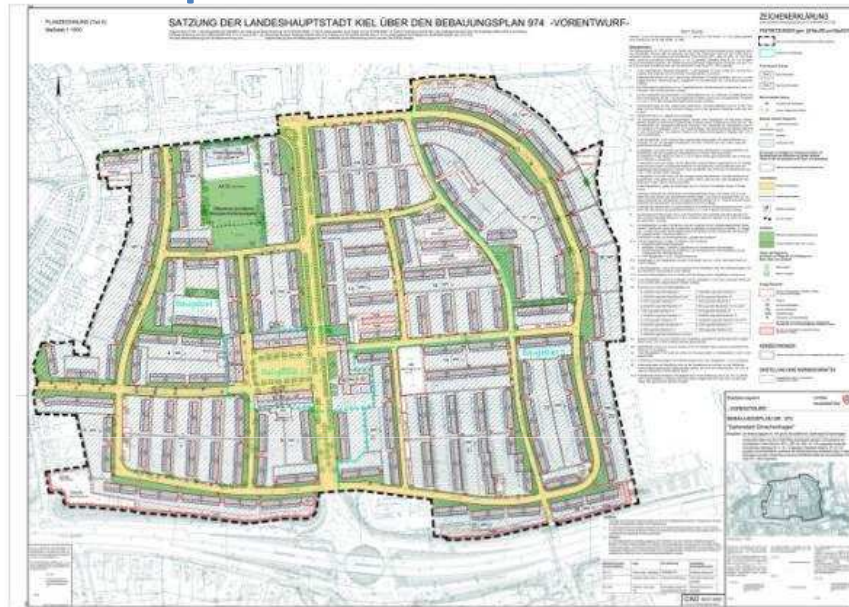
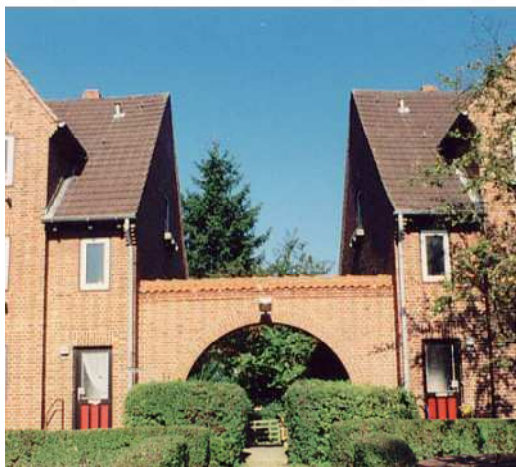
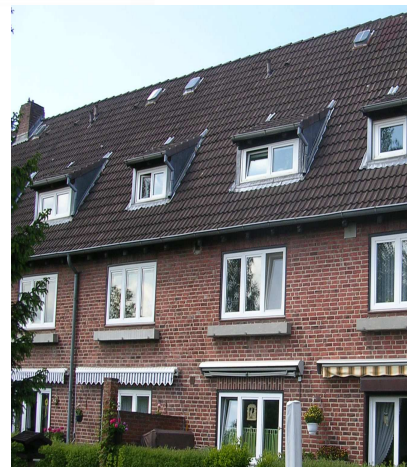
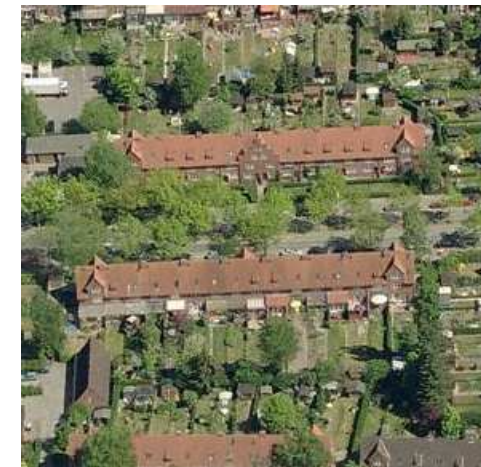
## Development Plan No. 974

- brick-red colored exposed brickwork
- matching color of bricks and joints, stonysize, bonds
- external wall insulation with brick slips
- roof pitch 53°
- color of roof covering red, red brown or anthracite; the same color for one structure
- eaves height 5.1 m
- continuous eaves line and ridge line
- front door canopy 1.4 x 1.0 m (width/high)
- no restrictions concerning solar collectors

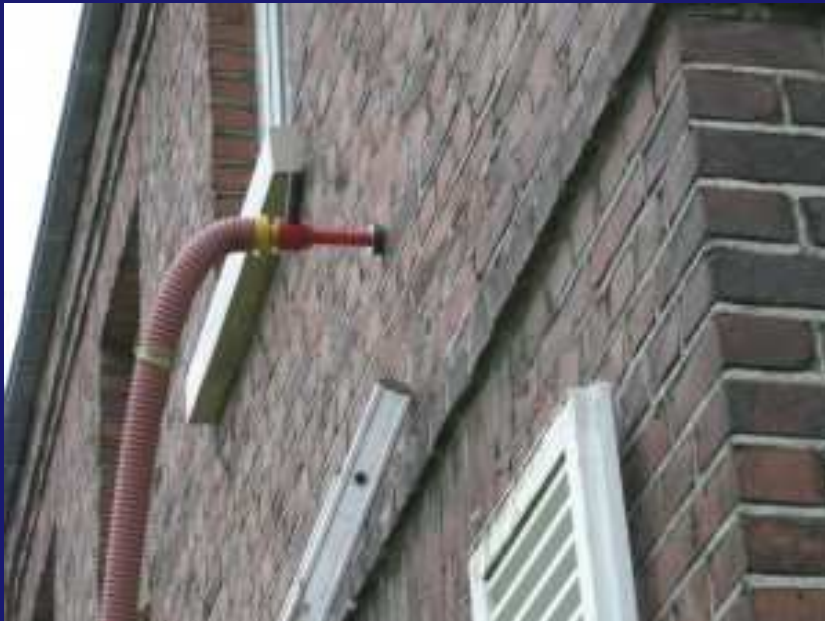
# Cavity wall insulation

With compressed air the insulating material is blown into the cavity through a hose from the outside of the house.

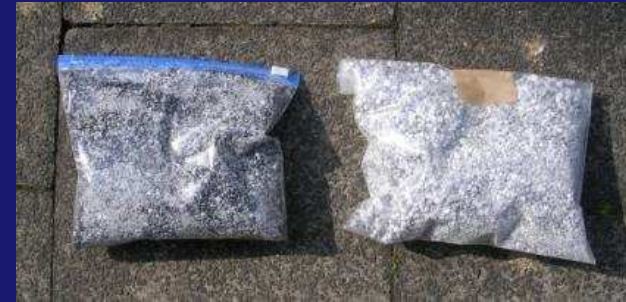
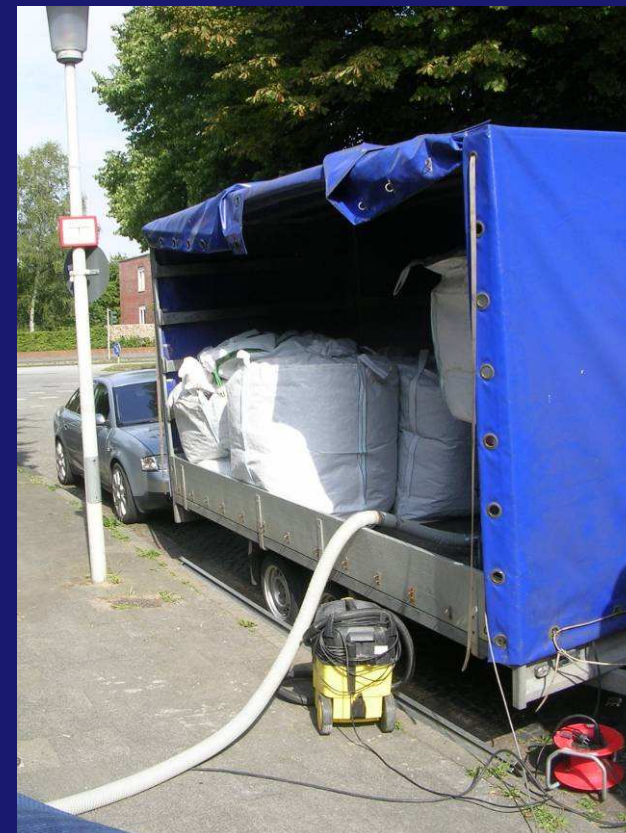
## Cavity wall insulation

Concerning cavity wall insulation special attention must be paid to walls that are not in good condition and that are regularly exposed to wind-driven rain.

Standards and guidelines for repairing joints, replacing bricks and applying water repellents correctly have to be developed in order to securely prevent rainwater from penetrating the outside wall and make the insulation damp.

If the walls of the building are not in good condition, rainwater can penetrate the outside wall and make the insulation (and the inside of the house) damp. The façade should be in good state of repair before cavity wall insulation is installed.

Vor einer Kerndämmung muss die Fassade auf Schäden untersucht werden. Eine Stein- und Fugensanierung kann – insbesondere bei Wetter exponierten Wänden – erforderlich sein.

Before insulation the cavity the façade needs to be examined for damage, brick and joint repairwork can be required, especially for weather exposed elevations.

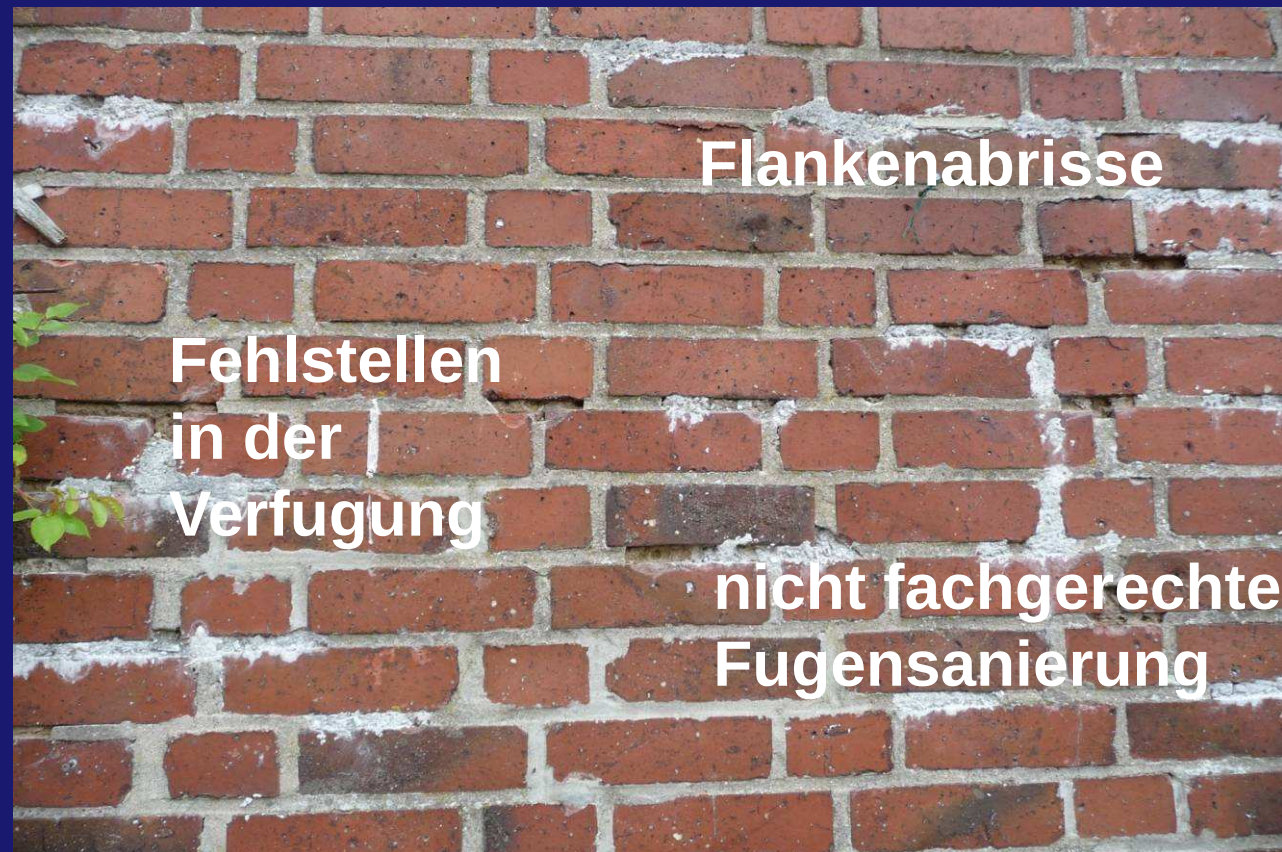
In this case it is necessary to repair the mortar joints.

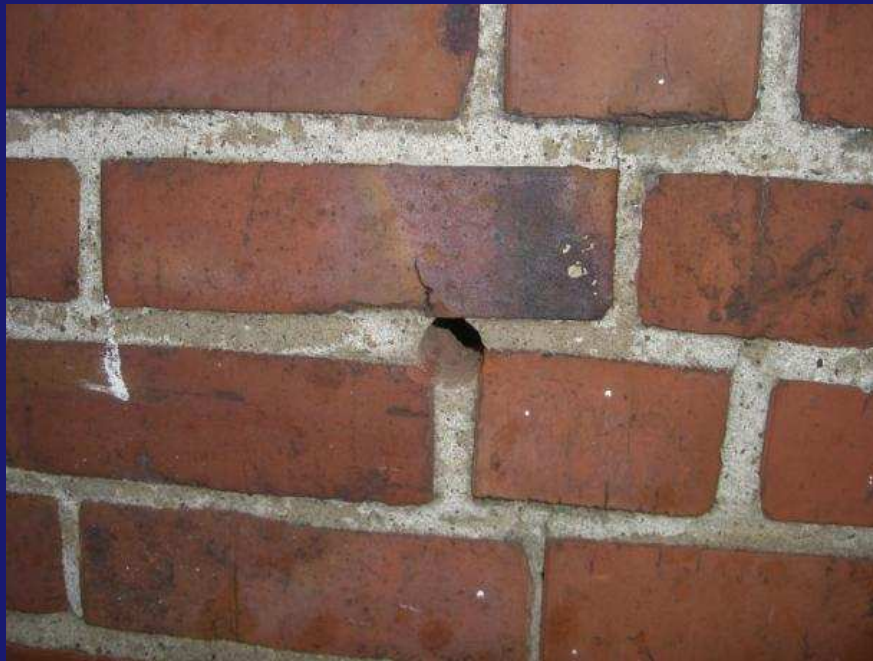
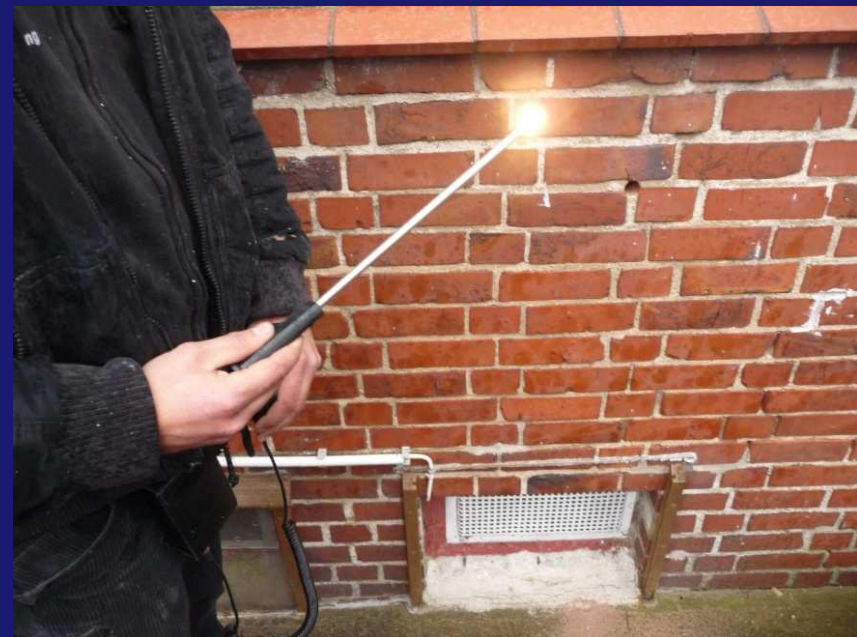
# Cavity wall insulation

- Endoscope Inspection of the cavity
- Inspection of Facade, Bricks and Joints

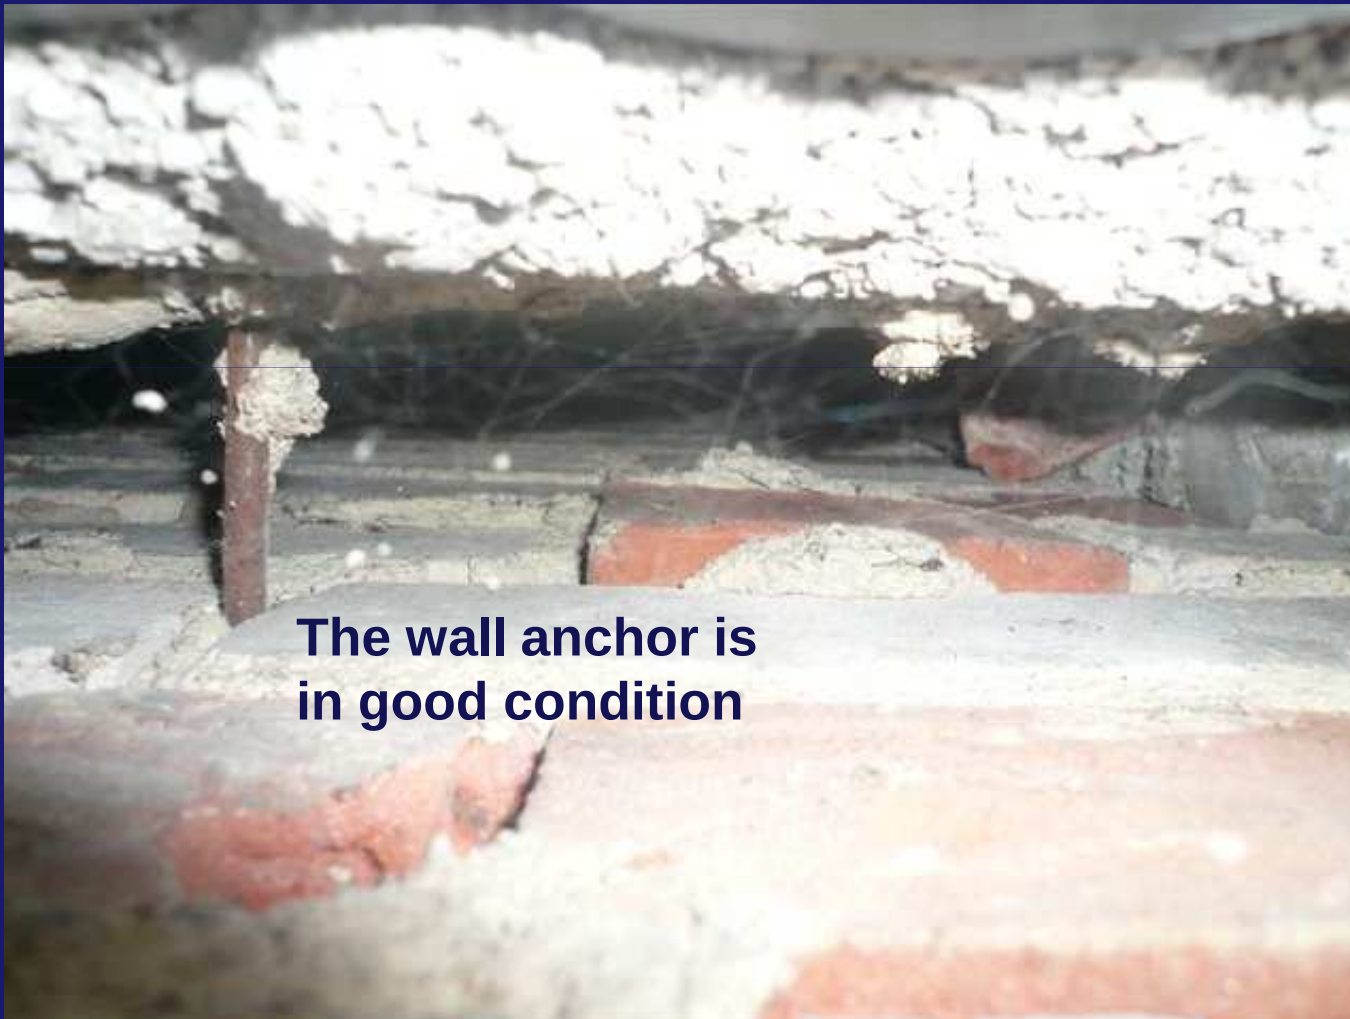
# Cavity wall insulation - Endoscope Inspection

**The wall anchor is  
in good condition**

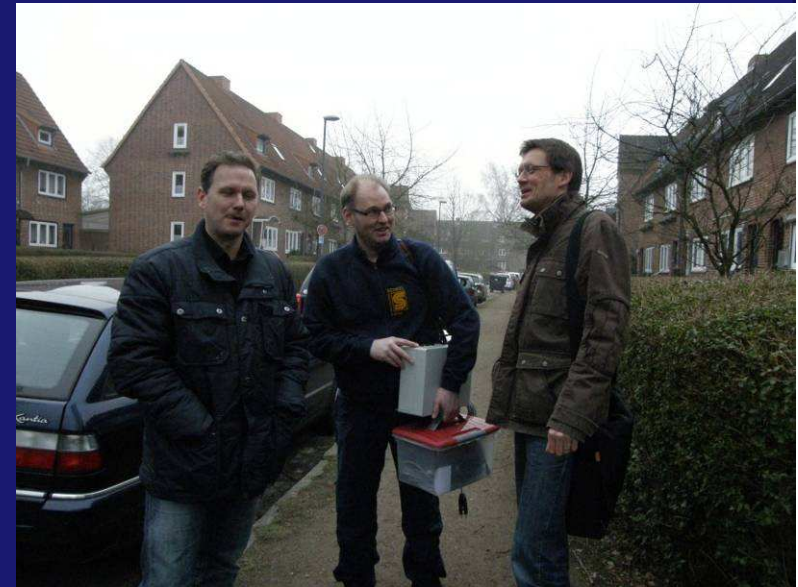
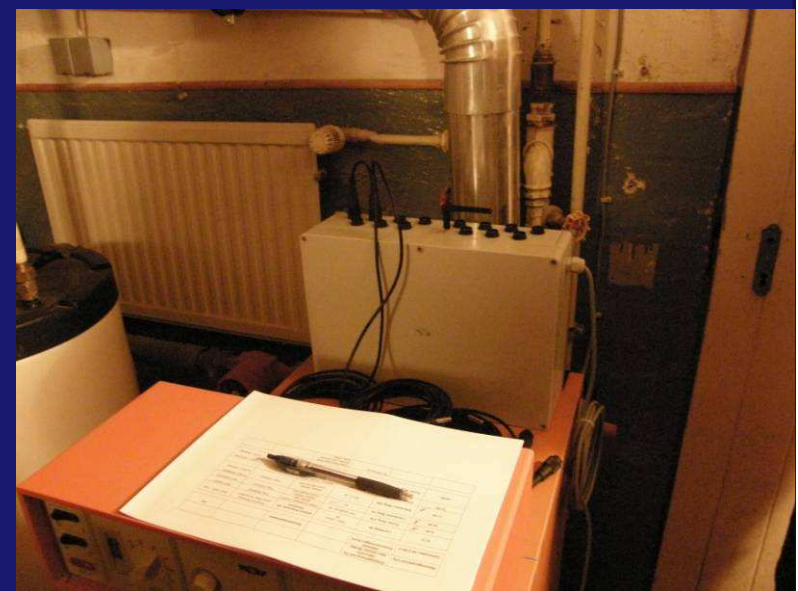
# „Heizungs – EKG“ ECG for the Heating System

Measuring the Performance of the Heating System with a monitoring system.

- measuring the temperatures of the heating system and warm water system
- measuring the runtime of the heater

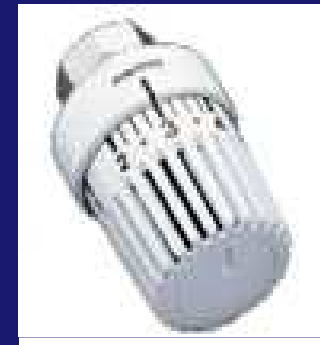
## Installation of pre-adjustable flow limiting valves

# Installation of new thermostats

Finding the  
right settings  
for the  
thermostats.
